## Problem of Damage to Curved Switch Rails in Ordinary Turnouts

### Summary

The article presents the problem of excessive wear of curved switch rails in ordinary railway turnouts, which is characterized by spallings and the decrement of material on a certain length of the switch rail near the tip. The problem is important, as such wear arises in turnouts on railway lines after several months of exploitation following modernization. The probable reasons behind the excessive wear of switch rails in railway turnouts are indicated on the basis of laboratory tests performed in accordance with PN-EN 13674-1:2011 and PN-EN 13674-2+A1:2010, as well as on the basis of simulations and analyses carried out by the finite element method (FEM).

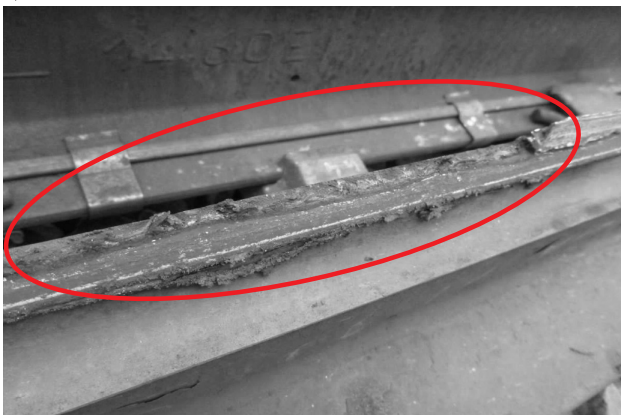
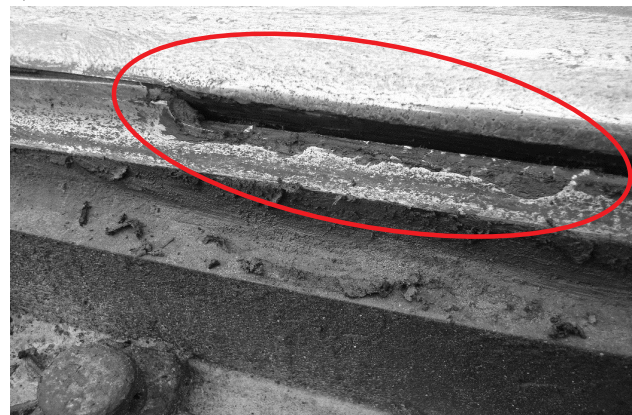
As already mentioned above, similar switch rail damage is a common feature of the analysed turnouts. In each of the three cases, such damage was characterised by spallings of material near the tip of the switch rail, which has arisen in each case at the same height from the foot of the switch rail profile (see Figure 3). In a zone adjacent to the decrement of material, propagating and developing cracks were spotted (see Figure 4). These cracks, in the case of further exploitation, would probably lead to expansion of the spallings of material near the tip of the switch rail. As there is no data about the load transferred by turnouts, the respective factor influence on the switch rail degradation rate cannot be determined. The found spall material (see Figure 5) constituted part of a switch rail, which broke away from the switch rail profile. However, the preserved spall surfaces indicated normal wear peculiar to interaction with rolling stock wheels.

Fig. 3. Damage to switch rails in the form of spallings of material a) and b) [photo. M. Czarnecki]

Existing spalls created a real hazard that the wheel flange would climb over the switch rail onto the stock rail and that the switch rail would be broken, consequently possibly leading to rolling stock derailment.

To avoid similar cases in the future, it is reasonable to use material with better mechanical properties than R260 steel, e.g. R350HT grade of steel, for the turnout switch rails for diverging tracks carrying high loads with high speeds of rolling stock. R350HT has a yield strength on the level of 700 MPa, which may cause a lowering of excessive wear and damages of the curved switch rails in ordinary turnouts. Moreover, precise fabrication and turnout assembling in the track, especially precise fabrication of the switch panel as well as continuous monitoring of the relative positioning of movable parts within turnouts, shall enable the switch rail damage hazard to be reduced.

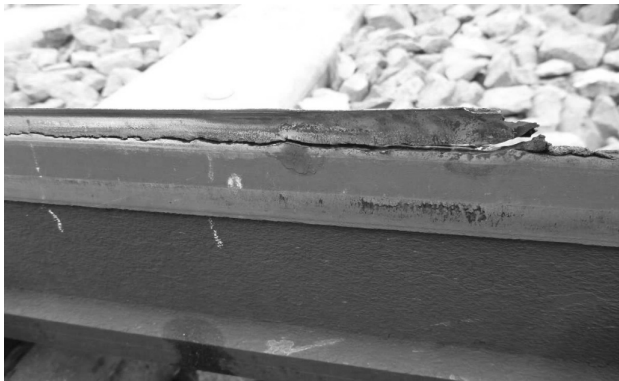
Fig. 4. Crack propagating near spallings of material of the switch rail [photo. M. Czarnecki]

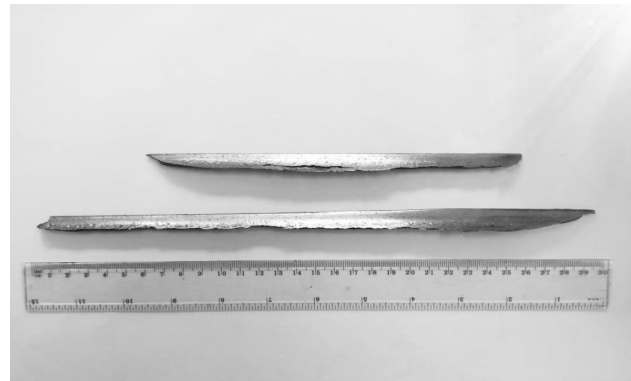
Fig. 5. Switch rail spall material [photo. M. Czarnecki]

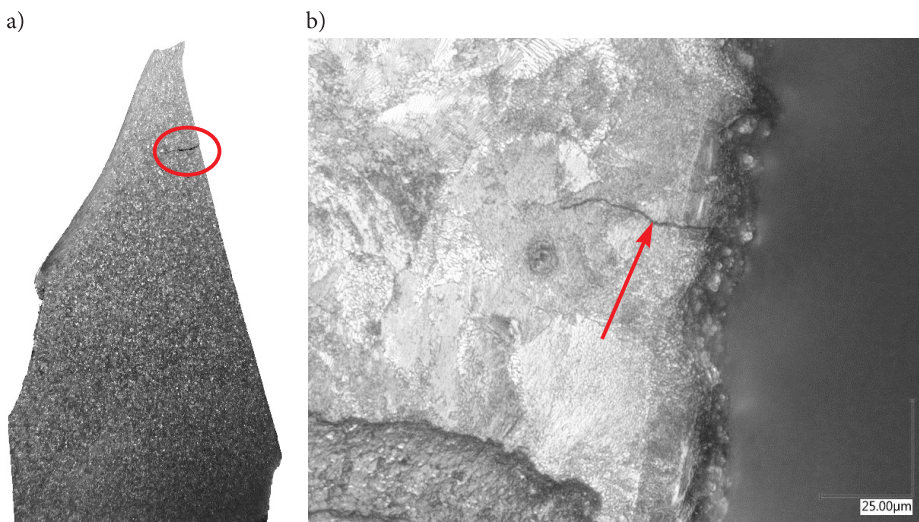
During microscopic tests, on samples which were taken near the damage, it was seen that the main crack was initiated on the switch rail and stock rail contact surface, then propagated deeper into the material (see

Figure 6a). Smaller cracks were spotted near the main crack. Smaller cracks, similarly to the main one, were initiated on the surface (see Figure 6b). This fact was also proven by magnetic particle inspection, which showed that discontinuities set themselves in a row located on one height (see Figure 7). Non-metallic inclusions located on the switch rail and stock rail contact surface could constitute places where cracks are initiated. They form potential structural indents where, in the point of contact between the inclusion and metallic body (rapid change in material properties), micro-cracks could arise, which as a result of further exploitation could merge together into one big crack. This can then lead to spallings of material and damage of the turnout switch rail. An example of the potential centre of material micro-cracks on non-metallic inclusions is shown in Figure 8.

Fig. 6. Part of the switch rail with a propagating crack (a), a small crack near the main one (b) [photo. M. Czarnecki]

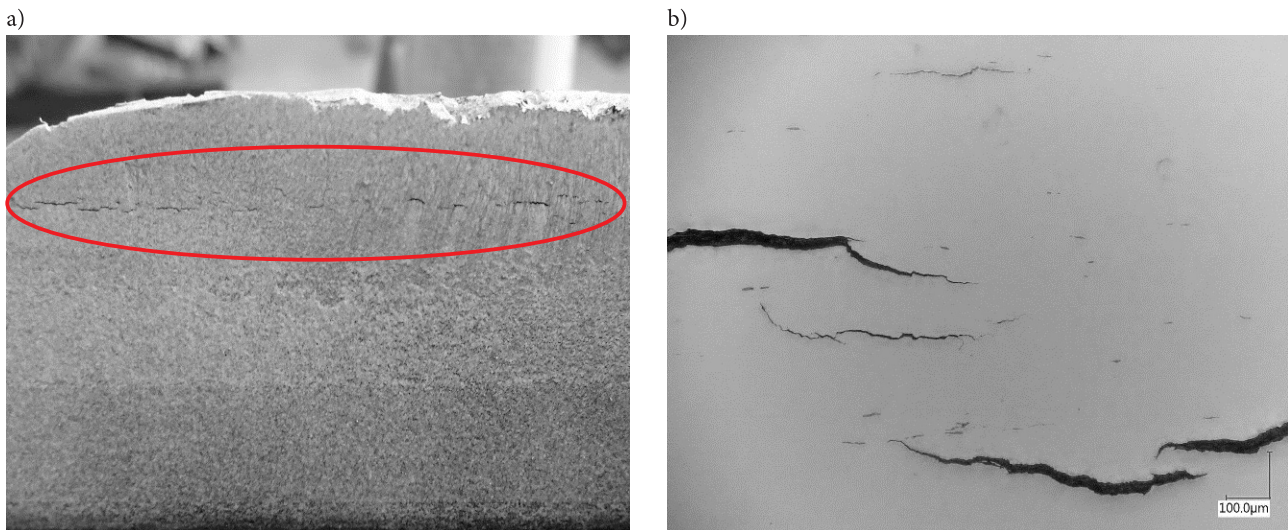
Fig. 7. Switch rail discontinuities in the place of contact with the stock rail detected during MT: tests (a) microscopic view of the marked area (b) [photo. M. Czarnecki]

Figure 14 shows the directions of tensile stresses occurring on the side of the switch rail contact with the stock rail, so in potential areas of switch rail damage centres (see Figures 6 and 7). The direction of tensile stresses is perpendicular to the longitudinal switch rail axis and the direction of arrangement of non-metallic inclusions in a switch rail, which is the most disadvantageous factor from the point of view of the appearance and propagation of cracks on non-metallic inclusions. This results in the occurrence of a row of cracks on a contact surface between the switch rail and stock rail, which was revealed during magnetic particle inspection (see Figure 7a).

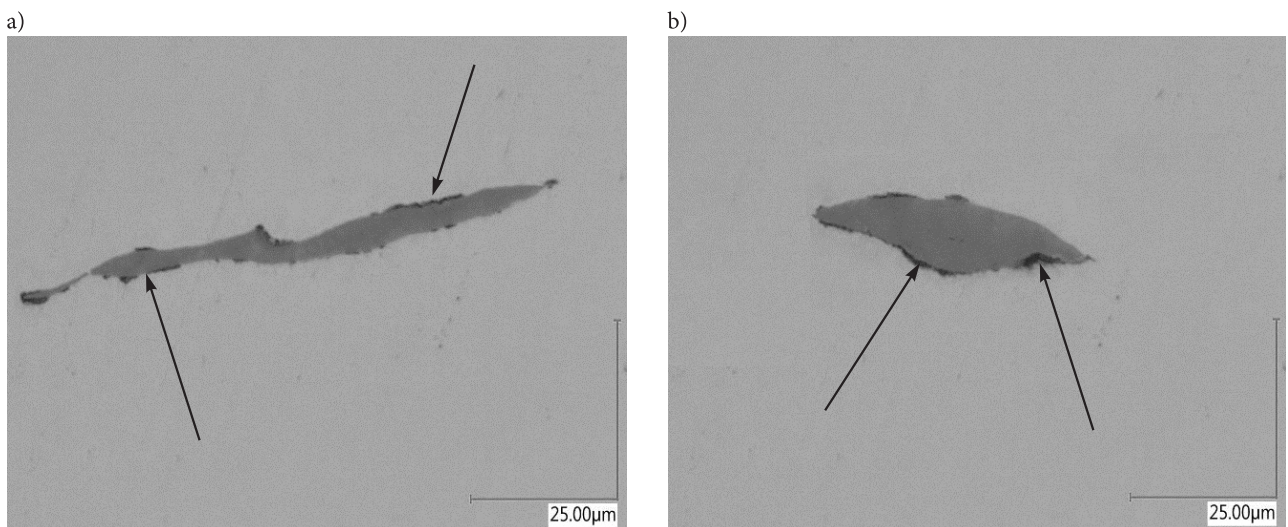
Fig. 8. Potential centre of material cracks on non-metallic inclusions (a) and (b) [photo. M. Czarnecki]

It should be mentioned that the fact that the switch rail material fulfilled the requirements regarding the presence of non-metallic inclusions (K3 index) did not mean that there were no inclusions at all in the material. Such inclusions are smaller and are not subject of analysis for establishing the value of the K3 material purity index.

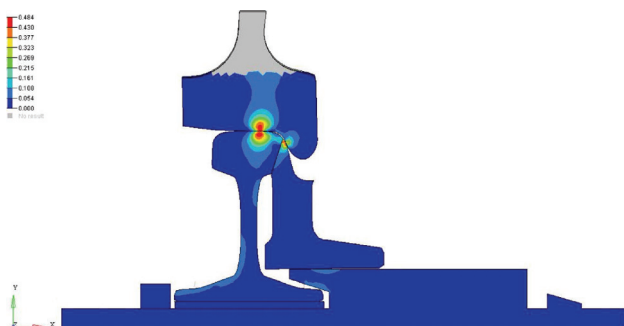
After creation of the 3D model and entering the appropriate material parameters, the stress field distribution (see Figure 10) was obtained for the wheel, stock rail and switch rail in the course of rolling stock passage through the turnout. It can be seen in Figure 10 that the highest stresses occur in the contact area between the wheel and stock rail (running surface) and in the contact area between the wheel flange and switch rail.

Fig. 10. Reduced von Mises stresses on a cross-section of the analysed arrangement in the course of rolling stock passage [own work]

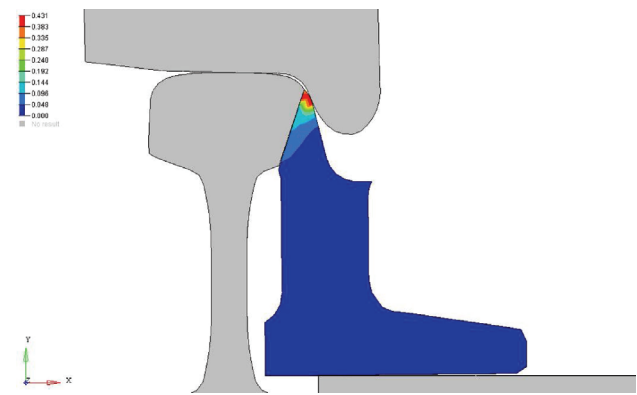
In the case of the switch rail, the largest stresses occur in the contact area between the wheel flange and switch rail and in the contact area between the switch rail and stock rail (see Figure 11). Occurring stress can reach about 430 MPa, which is a value close to the yield point value for the R260 grade of steel. The largest plastic deformation areas also occur in those places (see Figure 12).

Fig. 11. Reduced stresses on the switch rail cross-section in the course of rolling stock passage [own work]

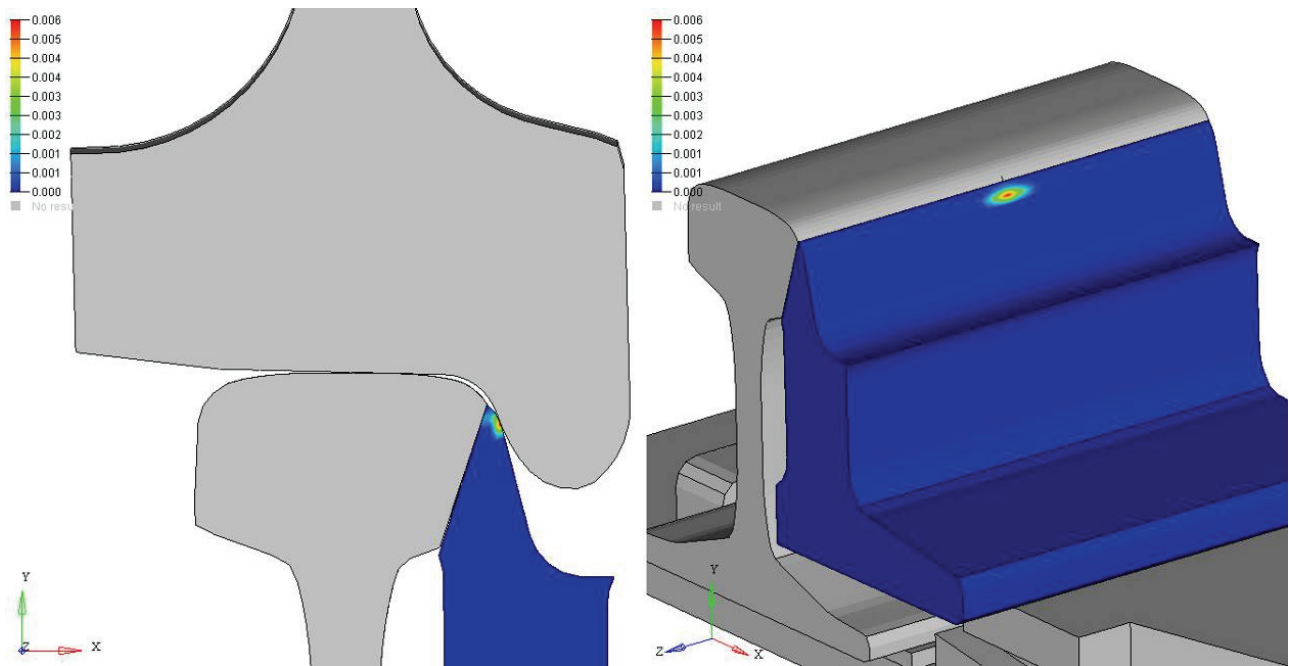
Fig. 12. Area of largest plastic deformations in the switch rail [own work]

Crack initiation places are determined by the character of the switch rail load caused by the wheel of passing rolling stock. Acting wheel flange in areas of the biggest switch rail plastic deformations (see Figure 12) has led to the grinding of material and material flow and, as a result, to wear of the switch rail (maximum measured side wear was 4.9 mm). The decrement of material and constant horizontal force acting on a switch rail could result in the appearance of stresses significantly higher than the ones obtained from FEM simulation. Those stresses could significantly exceed the yield point of the R260 steel material, thereby making it extremely dangerous in relation to turnout exploitation. It has to be underlined that, although values of compressive and tension stresses were obtained from FEM analysis concerning cases without any wear of the switch rail, stock rail and wheel and without any geometrical inaccuracies or errors in relative positioning (e.g. inappropriate intimate adhesion of the switch rail to stock rail), the assumed extreme side acceleration of  $2 \text{ m/s}^2$  caused, in the switch rail, stresses which are close to the yield

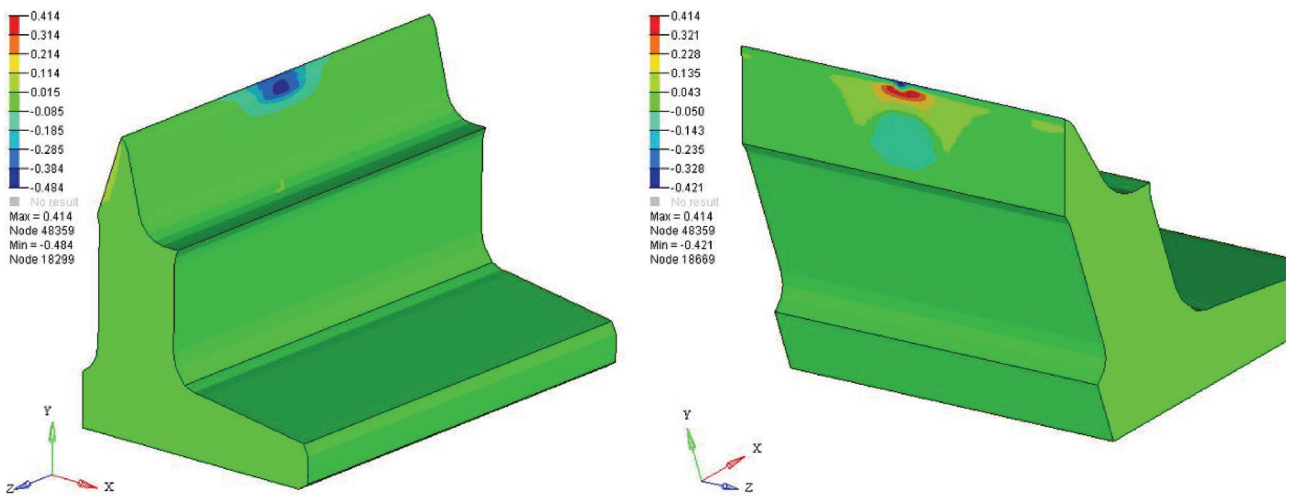
Reduced stress analyses show that, exclusively within the switch rail, the highest values occur slightly below the upper edge, both in places with the largest plastic deformations (contact with the wheel flange) as well as in the contact area between the switch rail surface and stock rail. In turn, the situation shown in Figure 13 is obtained when taking into account compressive and tensile types of stress. The areas being compressed are those of contact between the switch rail surface and the wheel flange (marked blue), whereas the areas which are tensioned are those of contact between the switch rail surface and stock rail (marked red). The highest compressive stresses obtained by simulation reached a value of about 420 MPa, whereas the highest tensile stress value was about 410 MPa.

Fig. 13. Main stresses after considering compression – blue colour and after considering tension – red colour [own work]

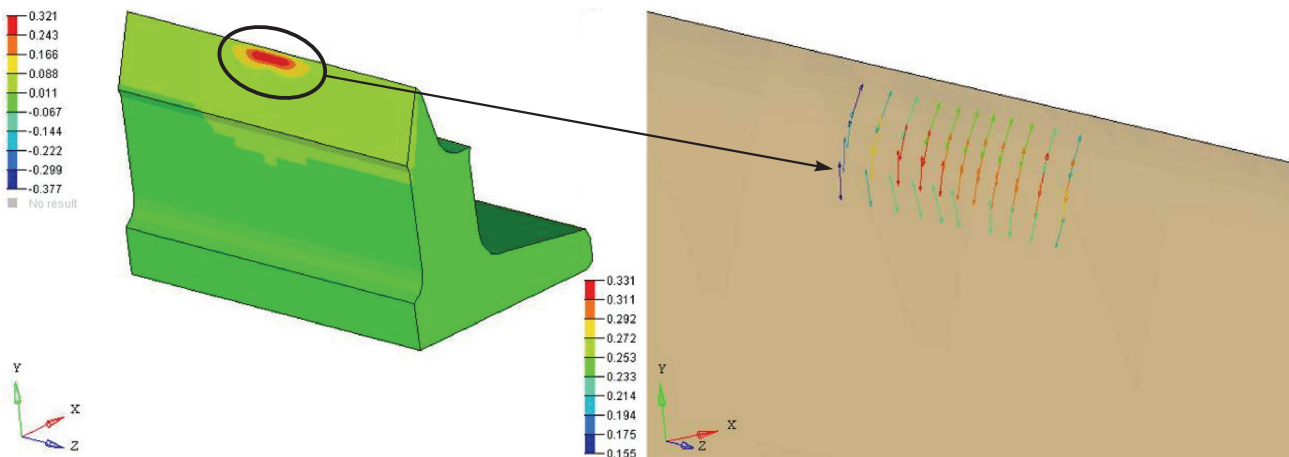
Fig. 14. Tension stress directions (first main stress  $\sigma_1$ ) occurring in a switch rail [own work]
