Tactile Elements on Rail Transport Platforms – Assessment of Solutions in the Light of Binding Acts of Law

Summary

Keywords: platform, danger zone, tactile elements

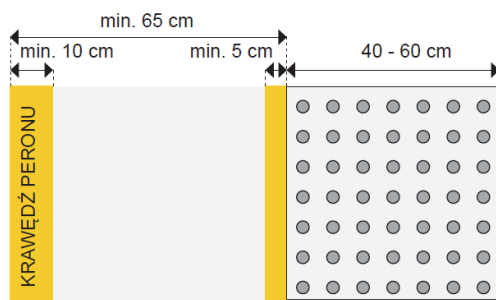
Fig. 1. Size of platform edge marking [9, 11]

The Warsaw Metro belongs to this mode of transport whose all platforms have been marked in a uniform way with tactile elements for blind and visually impaired persons. This indication was consulted with blind people's environment and was included in the PZN – Polish Blind Association's standards. In order to provide contrast of the warning line, a black strip next to it is mounted on light platform surfaces. Examples of marking is shown in Fig. 1, 2.

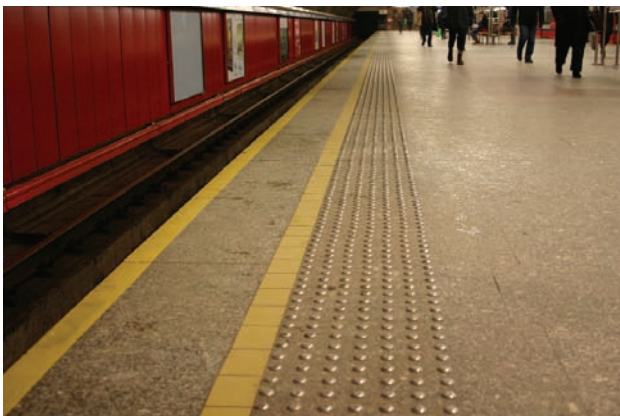
Fig. 2. View of marking on underground platform [Photo J. Poliński]

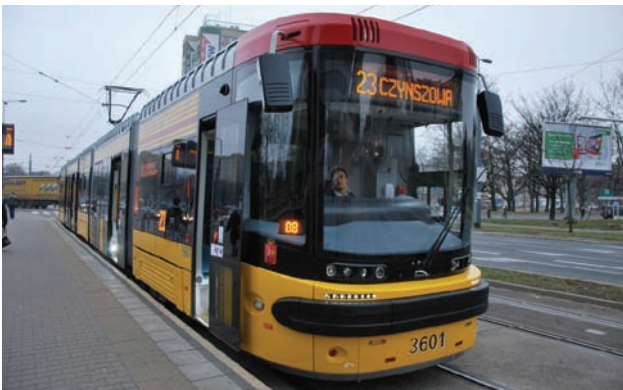
Fig. 3. Edge of tram platform made in accordance with PZN recommendations – general view [20]

As regards urban (public) transport stops (inter alia tram platforms), PZN recommends the following solution [10]: the danger area of the platform at the stop should be marked in the following way: „(...) 0.10–0.15 m from the edge – a yellow strip (line), 0.10–0.15 m – a contrasting black strip (line), 0.30 m – a grey slip-resistant area, and a warning strip of 0.40–0.50 m width along the entire length of the platform. The total width of the danger area should amount to 0.90–1.1 m” – as presented in Fig. 3.

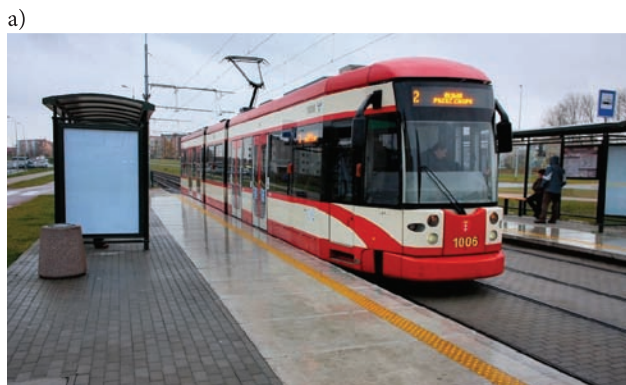
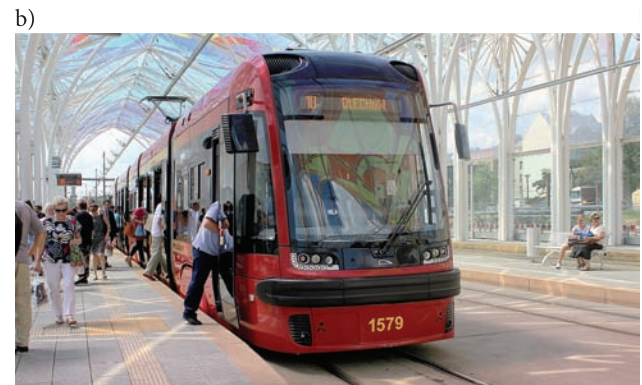
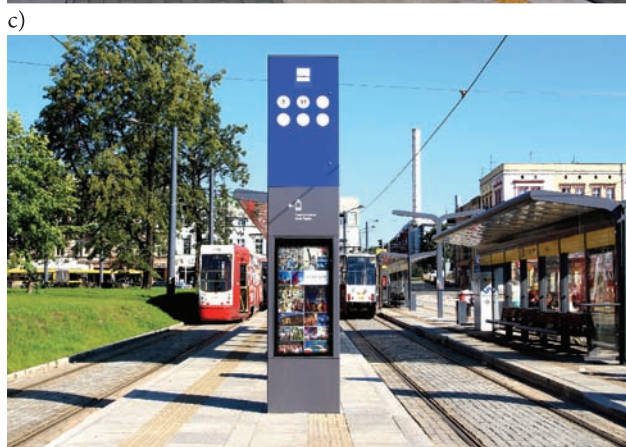
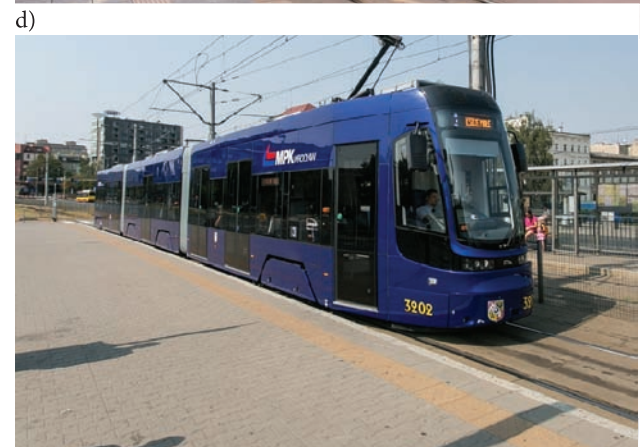
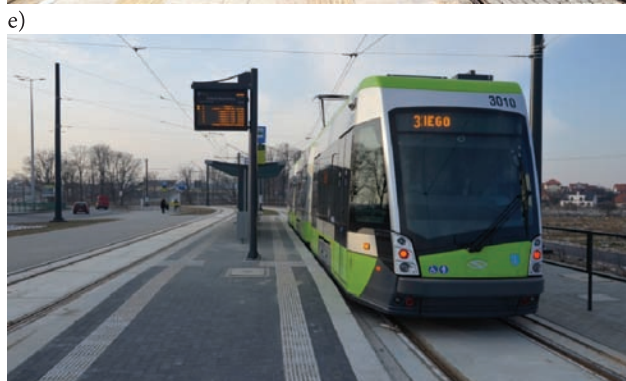
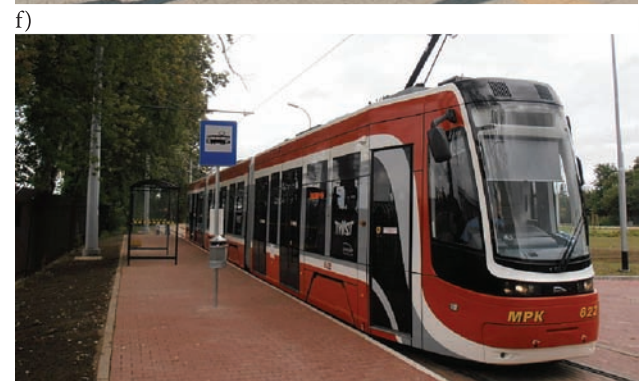
Fig. 4. Examples of new tram platforms' markings in different Polish cities: a) Tram platform in Tri-City [17], b) Tram platform in Łódź [19], c) Tram platform in Chorzów [18], d) Tram platform in Wrocław [21], e) Tram platform in Olsztyn [22], f) Tram platform in Częstochowa [23]

Having reviewed different solutions used so far of tram platform edges, it can be stated that there is a great deal of freedom in the tactical elements' shape, size, spacing and shape of truncated domes, width of warning surface, principles of placing tactile elements in relation to platform edge, choice of material that tactical elements are made of, colours guiding movement on the platform and ensuring safe distance to the edge of the platform. Examples are shown in Figures 4.

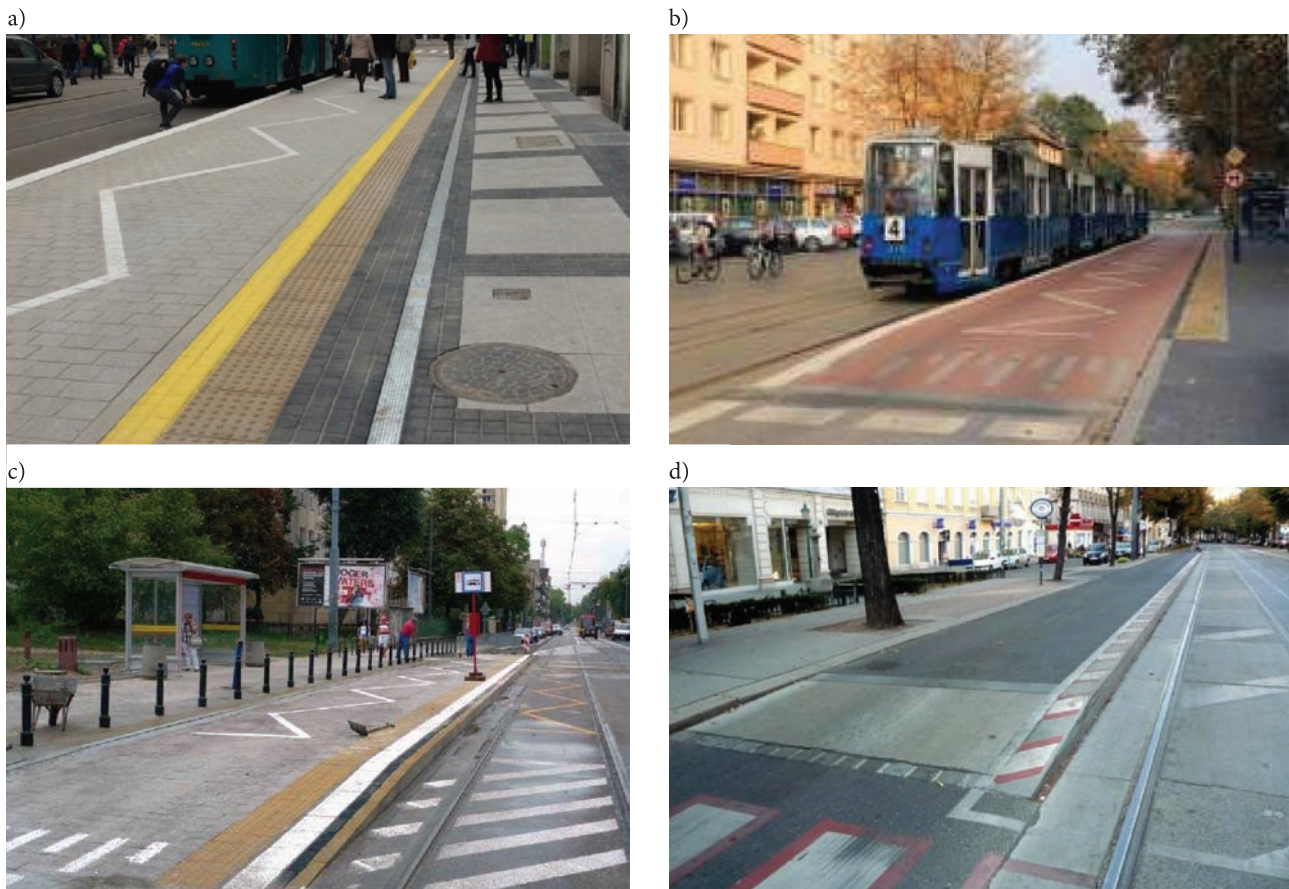
Fig. 5. Examples of tram platform Vienna style markings: a) Poznań [24], b) Kraków [25], c) Warszawa [26], d) Wrocław [27]

the tram, the solution called Vienna style tram stop is often used. It is a kind of a tram platform where the level of the street is the same as the pavement's. Such a solution facilitates safe boarding and exiting the tram for persons with disabilities and decreases a possibility of collision with other means of transport. Moreover, it serves as a natural barrier acting as a speed bump. Appropriate platform construction makes the driver slow down in its area. Therefore, there is a limited risk of hitting a passenger entering or leaving the tram. Examples of tram platform Vienna style markings are shown in Fig. 5.

The PZN document does not take into account markings for the blind on such a type of tram platforms. Thus the Warsaw and Poznań solutions are worth taking into consideration. Markings on such types of tram platforms in Poznań are located before a raised lane and consist of a yellow line of 200 mm width with a tactile warning surface. It is adjacent to a fragment of contrasting surface of the pavement

situated on the same height as the platform. The edge of the lane raised from the trackside is marked with a white line contrasting with the surface. Chosen colours are important for partially sighted persons.

A different solution for the Vienna style tram stops has been applied in Warsaw where tactile markings are placed in the lane which passengers walk on after the tram stops. There is also a warning surface on the pavement next to the kerb, forgetting the road gauge. Pillars situated there constitute an additional obstacle for the blind waiting for the tram. It is worth noticing that this disputable solution is included in the draft of standards developed for the capital city of Warsaw [13].

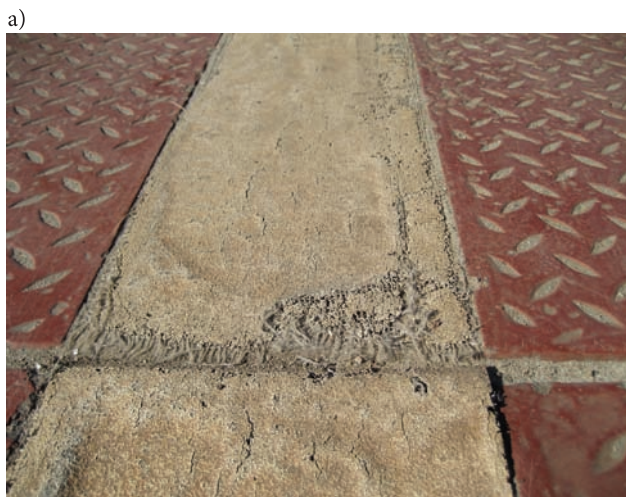
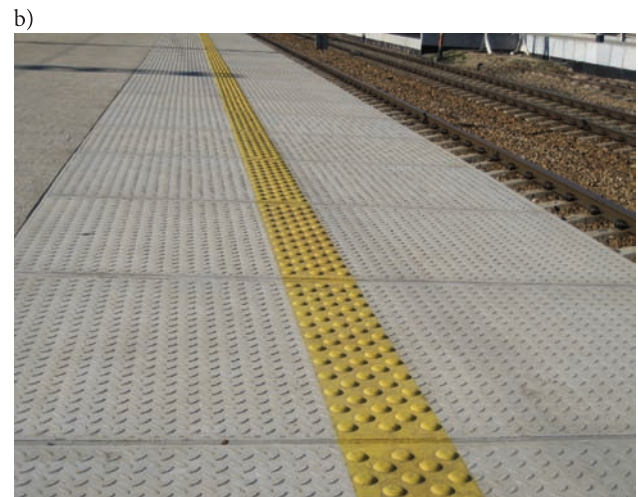
Fig. 6. Examples of platform tiles: a) damaged warning line on tiles without tactile elements, b) tactile warning surface placed on warning line [Photo J. Poliński]

monly applied. Such a solution had been used before PRM TSI of 2007³ entered into force. Therefore on the first tiles, apart from a warning surface produced in different techniques (see Fig. 6a) tactile markings were not placed. When the mentioned above specification for interoperability was implemented and due to lack of legal regulations as regards tactical elements' use, some producers of platform tiles placed tactical elements on the warning line (see Fig. 6b).

Thirdly, certain parameters of tactile elements regarding the shape and size of a single truncated dome have not been defined. Moreover, it has not been stated if the truncated domes could be placed alternately as shown in Fig. 6.

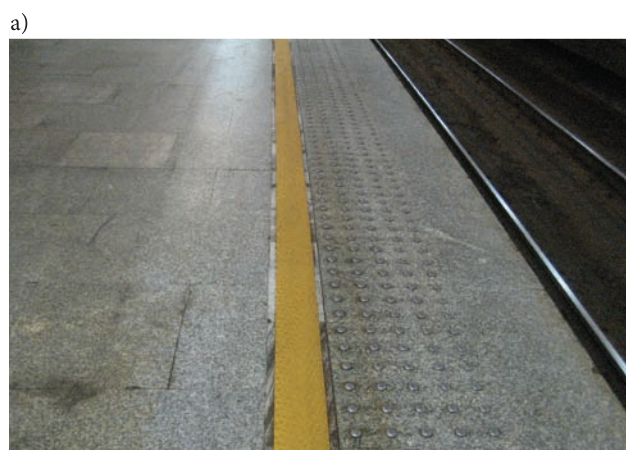
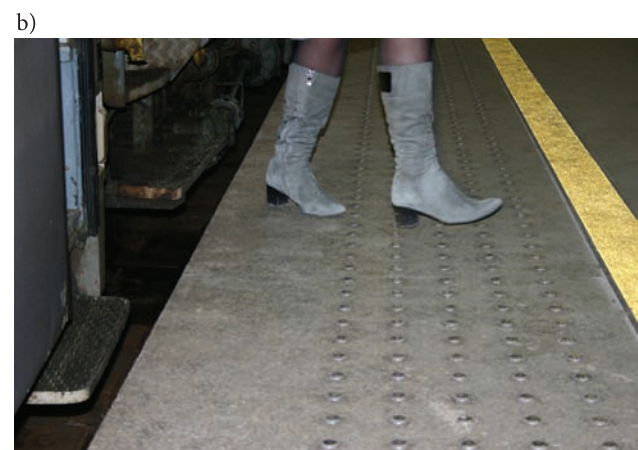
Fig. 7. Truncated domes within danger area at Warszawa Śródmieście railway station (a), direct exit from the carriage onto slippery truncated domes poses a threat for passengers (b) [Photo J. Poliński]

At some railway stations such as Warszawa Śródmieście or Warszawa Centralna, the tactile warning surface was placed on the danger area's surface (see Fig. 7a). Metal truncated domes pose a threat not only for blind persons but also for all passengers leaving a train due to an increased possibility of slipping even on a dry surface of the platform (see Fig. 7b).

guidance paths, such a role can be taken over by tactile warning surfaces, which is stated in point 4.2.1.1.2 item 8 of Commission Regulation No 1300/2014 [4]. In the case of Warszawa Śródmieście railway station where platforms are not fitted with guidance paths, the use of tactile warning surface for movement in a direct neighbourhood of the platform edge collides with providing safety for blind persons.

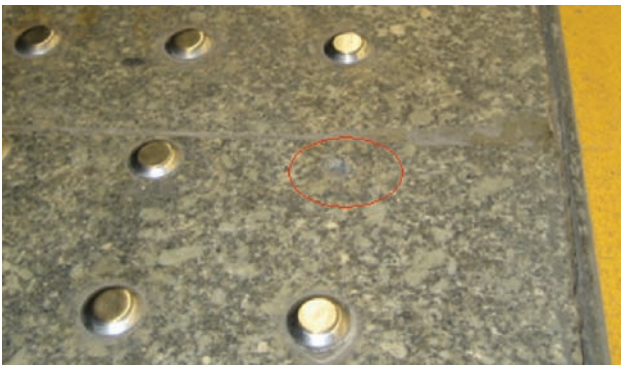
Fig. 8. Torn off truncated dome from the warning strip
[Photo J. Poliński]

In some railway objects and facilities, it is practiced to use tactile elements (truncated domes, corduroy paving) of steel. The drawback of such elements is their slippery surface. Slipperiness is increased in case of moisture or frosting during the winter months (it refers mainly to tactile elements exposed directly to weather conditions). Therefore this kind of tactile elements is criticised by passengers. Furthermore, single tactile elements should be carefully and firmly fitted to the surface. Losses of truncated domes (see Fig. 8), which should be immediately refilled, have been noted on some platforms.

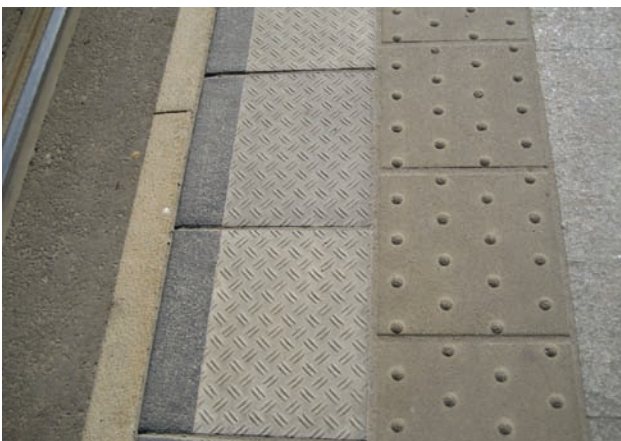
Fig. 9. Damaged corduroy bars in an underground passage under platforms at Warszawa Wschodnia railway station [Photo J. Poliński]

Also corduroy paving, especially metal bars badly fitted to the surface of guiding paths (see Fig. 9) pose a threat for passengers' safety. It happens that curved bars may cause an accident involving pedestrians and

Tram platforms in Warsaw are marked in accordance with the requirements of the Polish Blind Association. Here not only blind persons have been cared for, but also partially sighted persons, for whom a contrastive (yellow – black) line is placed at the edge of the platform. An important deficiency, however, is the loss of original colour intensity due to sun rays and changeable weather conditions. In the case of Warsaw, there are also reservations relating to quality and durability of concrete tiles with tactile elements of height over 4–5 mm and lenticular shape, the base diameter of 20 mm (see Fig. 9a). In places of intense passenger traffic flow, these elements are prone to accelerated wear and consequently tactile by feet characteristics are seriously affected. In wintertime when shoe soles are thick, the possibility to detect small domes is poor or nonexistent. Due to this fact, during the modernisation work being carried out, tiles are being exchanged into new ones on which tactile elements are much better discernible for blind persons, similarly to truncated domes mounted in the Warsaw Metro (see Fig. 9b).

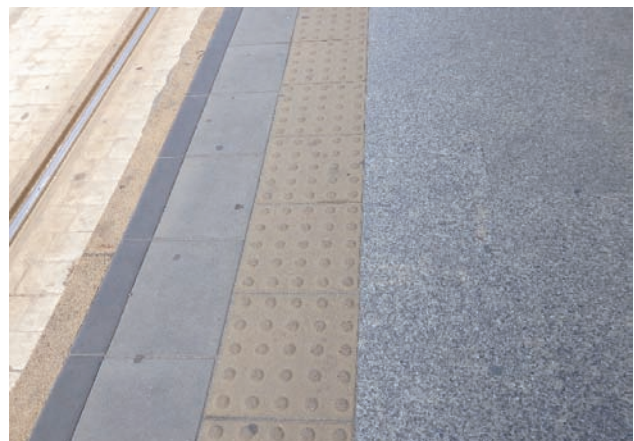
Access to a tram platform is usually connected with crossing a street. It is disputable to place warning surface directly at the kerb. The regulation relating to roads and streets used by cars [12] introduces the notion of road gauge (strip of 0.5 m width on each side of the

road/street) which makes it impossible to place there any elements (road sign and lamp posts, barriers etc.).

Blind people who feel tactile elements with their feet may stand in the road gauge area and be exposed to collision with any protruding element of a vehicle in motion. Therefore the provision included in PZN guidelines [9] is highly disputable:

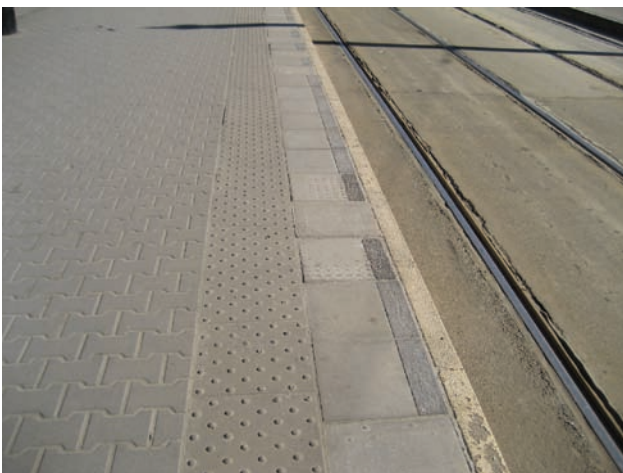
Fig. 10. Example of incorrect maintenance of platform edge
[Photo J. Poliński]

The exchange of destroyed or damaged tram platform elements should aim at mounting identical products. There is no point in replacing elements with different ones. Incorrect maintenance of platform surface results in the loss of properties assumed by the designer and downgrading the construction aesthetics (see Fig. 10).
