# Experimental and Simulation Tests of the 1 MN Screw Coupling

## Summary

The article describes the requirements that screw couplings must meet before they can be put into service. In the paper, the results of fatigue testing simulating a 30-year service life of a screw coupling are presented, as well as the results of CT and Nondestructive Testing, NDT, non-destructive magnetic particle inspection, and then, the test results are compared with the results obtained with the application of Finite Element Method, FEM.

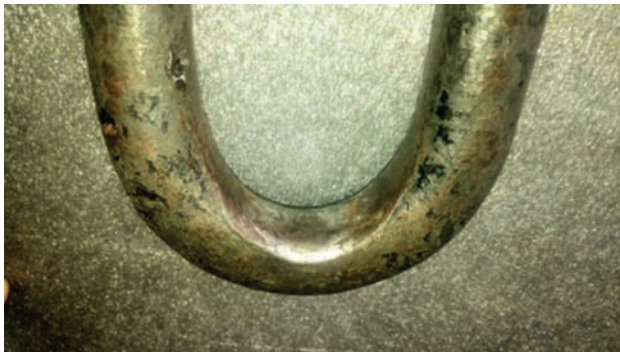
Fig. 1. View of the worn (in operating conditions) surface of the bow caused by abrasion against the draw hook [pic. A. Aniszewicz]

tact between the components and the transmission of considerable forces over a small area of the surface, surface friction occurs here, resulting in a high concentration of stresses. As a result of the mutual friction of the contacting surfaces, significant wear is observed over time, as shown in Figure 1.

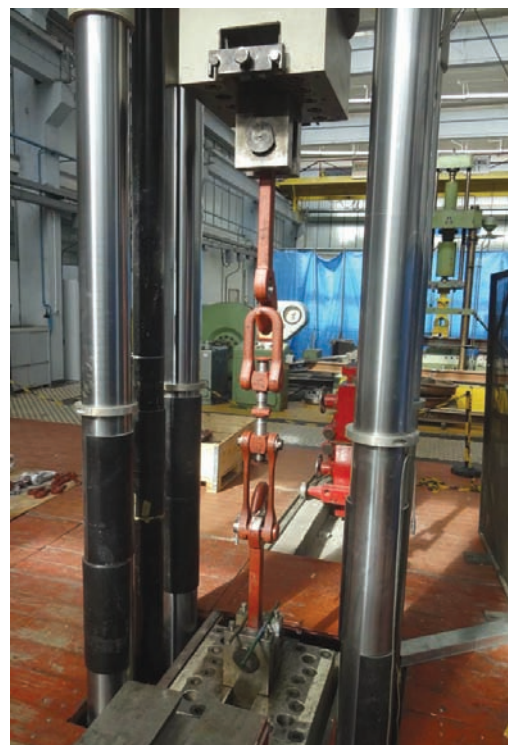
Fig. 2. 1 MN screw coupling during fatigue testing using an LFV machine [pic. D. Kowalczyk]

Testing of the 1 MN screw coupling was carried out on the LFV fatigue testing machine shown in Figure 2. Figure 3 shows an example graph of the applied fatigue loads. The graph shows 698 load cycles of low amplitude  $\Delta F1$  and one cycle of  $\Delta F2$  high amplitude with values taken according to Table 2. Each block consists of dynamic loads ranging from 10 kN to 180 kN, followed by a 575 kN load cycle. The load pattern for given types of couplings results from the requirements described in EN 15566 [1] and Table 2. The described fatigue loading block was performed 2150 times, which corresponds to a simulated operation of the coupling for 30 years.

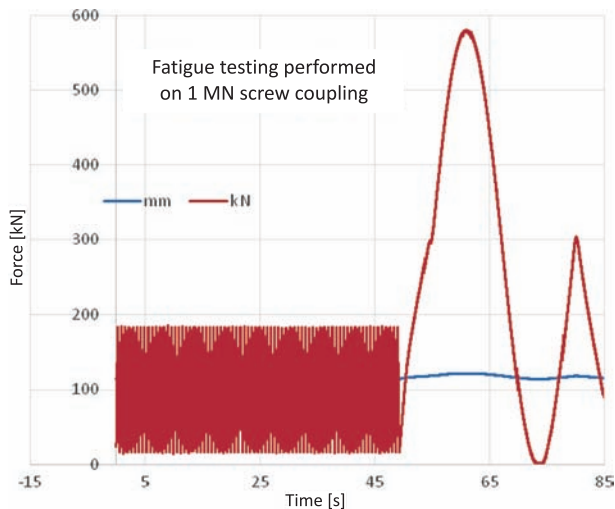
Fig. 3. Fatigue loading block for 1 MN screw coupling [study by D. Kowalczyk].

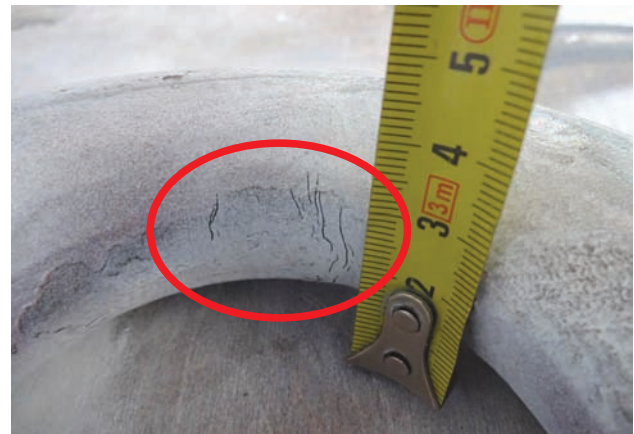
Fig. 4. Cracks in the 1 MN bow after fatigue testing using the magnetic particle inspection [pic. D. Kowalczyk]

After completion of the fatigue testing, the screw coupling was subjected to magnetic particle inspection [8, 9]. The surface condition of the bow where it meets the hook was assessed. Figure 4 shows in green the area showing the results of these tests. The tested coupling revealed superficial cracks, the size of which does not exceed permissible values. According to the requirements and criteria for the assessment of the surface condition after fatigue testing, discontinuities – cracks of length and depth up to 20 mm are permissible according to the requirements of the standard [1].

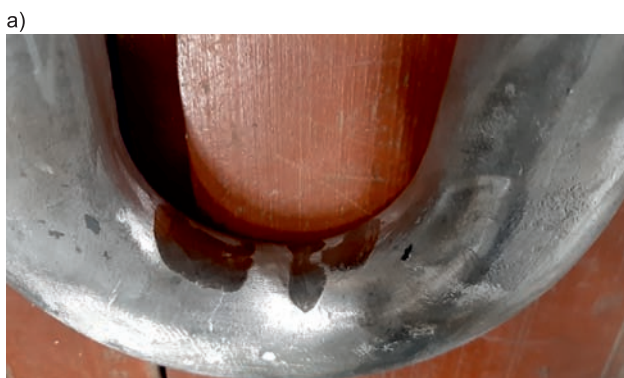
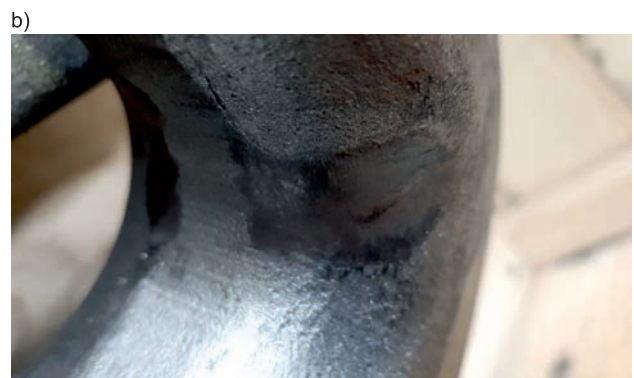
Fig. 5. View of the worn coupling bow surface caused by friction with the draw hook: a) left view, b) right view [pic. D. Kowalczyk]

Figures 5a and 5b show a view of the worn coupling bow surface caused by abrasion against the draw hook during fatigue testing. Fatigue tests performed with a fatigue testing machine indicate that the stress distribution in the contact area of the hook and bow

may be different and non-uniform leading to significant local abrasive wear.

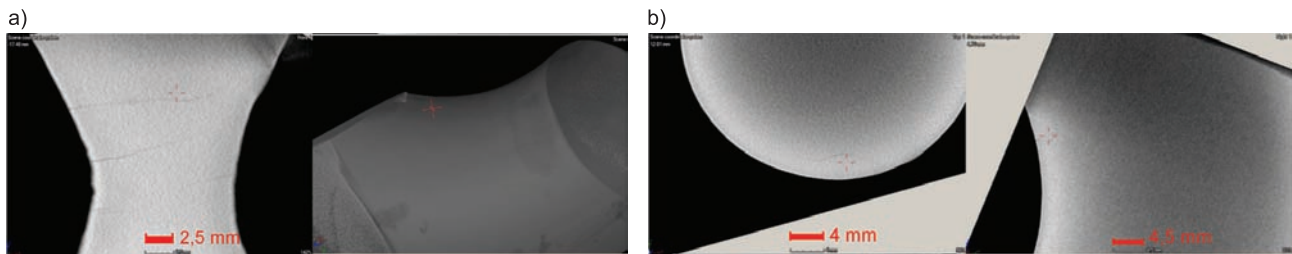
Fig. 6. Observations of the extent of cracks inside the material of the 1MN screw coupling bow after fatigue tests performed with the use of computer tomography: a) view in cross-section, b) view in longitudinal section [study by D. Kowalczyk]

The images obtained by CT scanning allow to observe crack propagation path in 3D and its actual length and depth to be determined. It should be noted that the requirements of current standards specify only the surface length of defects [1]. In fact, based on observations of tested sample, it has been found that cracks can propagate as deep as 5 mm below the material surface. The cross-section and longitudinal section of cracks within the material of the 1 MN screw coupling bow after fatigue tests are shown in Figures 6a and 6b.

Non-destructive testing including magnetic particle inspection and CT scanning confirms that the contact surface of the bow and hook is an area particularly prone to crack occurrence and propagation. CT scans showed that in the case in question, the crack propagated up to 5 mm deep into the material of the bow (in the area of contact with the hook surface). The simulation tests and FEM analyses carried out confirmed the existence of a high stress concentration in this area and large stress differences in the compression and tension area (hook and screw coupling bow contact). The simulations indicate the importance of the geometry of the shape and surface fit of the bow and hook, which significantly affect the stress distribution in the components. The CT scanning made it possible to assess the depth of the cracks, to determine whether they are surface defects or cracks propagating into the material, and to observe in 3D their actual propagation path in the bow material.

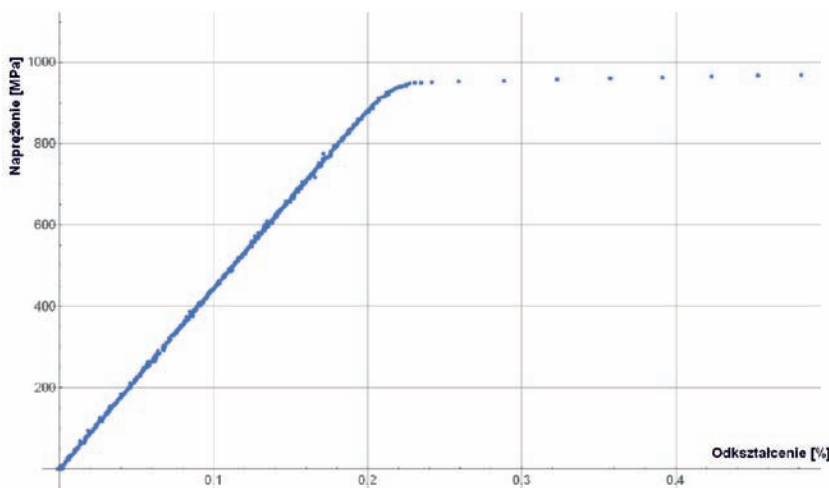
Fig. 7. Tensile test (stress vs. strain) of a sample made of 40CrMn4 steel [study by D. Kowalczyk]

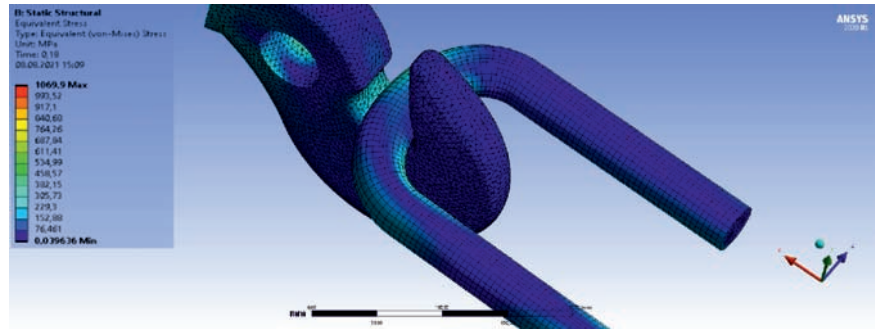
Fig. 8. Von Mises stress for a load of 200 kN [study by D. Kowalczyk]

The test results presented in Figures 8, 9, 10 and 11 clearly confirm the causes of cracks in the contact area of the hook and bow. They are caused by the occurrence of extremely high stress values and close compressive and tensile stress zones in the bow and by high pressures on the contact surface of the bow with the hook.

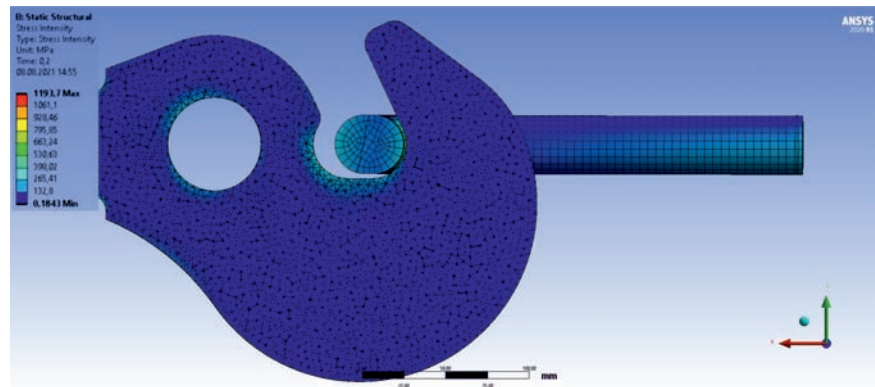
Fig. 9. Stress for plasticity under load of 200 kN [study by D. Kowalczyk]

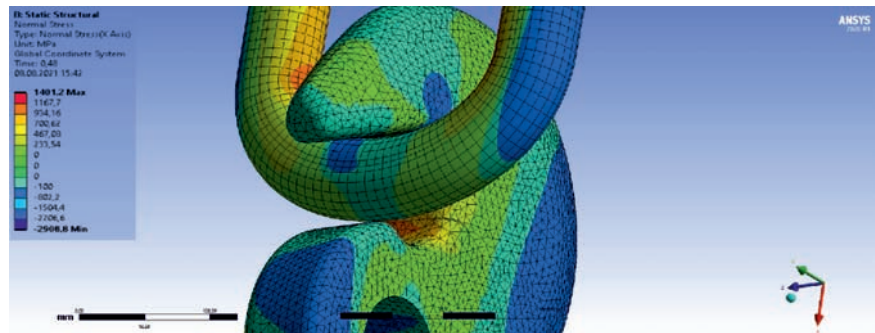
Fig. 10. Graphical representation of the stress distribution in the contact area of the hook and bow of a screw coupling (normal stresses) under load of 575 kN [study by D. Kowalczyk]

both compressive and tensile stresses in the material of the screw coupling bow arises in the contact area of the hook and the screw coupling bow. The simulation results obtained reveal tensile stresses locally capable of exceeding 1,000 MPa and compressive stresses as high as 1,500 MPa (Fig. 10 and 11). The analysis of

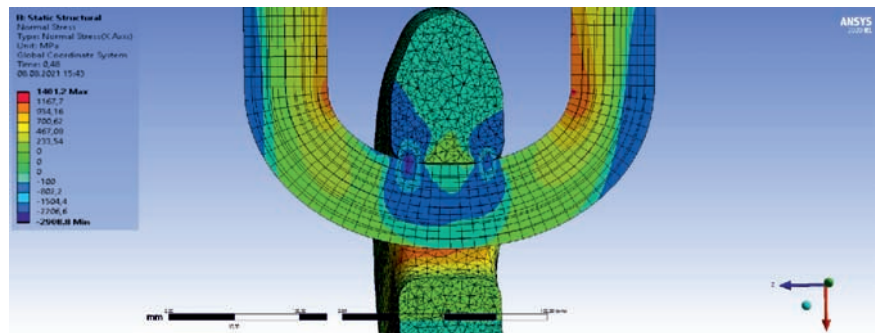
Fig. 11. Graphical representation of the stress distribution in the contact area of the hook and bow of a screw coupling (normal stresses) under load of 575 kN [study by D. Kowalczyk]

Figure 11 shows that the shape of the contact area and the area of operation of the bow and the hook are important for the stress distribution in this area. The better the fit, the more evenly the stresses are distributed over the whole contact area, so that their average value can be lower.
