Determination of the Susceptibility of the Rail Running Surface to Cracks

The article presents one of the main types of rail defects – cracking – and the factors that influence its size. A new test method was used, involving pressing a 60° cone into a prepared rail section. It was found that the forming surface crushing of the material caused by the load, as well as the driving dynamics of the rolling stock, is the reason for the formation of *head checks* on the rail surface. Additionally, it was observed that the structure of the layer of the rail running surface has a significant impact on the formation of cracks. A method was proposed to determine the susceptibility of the rail running surface to rail defect formation using the W_p coefficient.

Keywords: rail head check, running surface, susceptibility coefficient

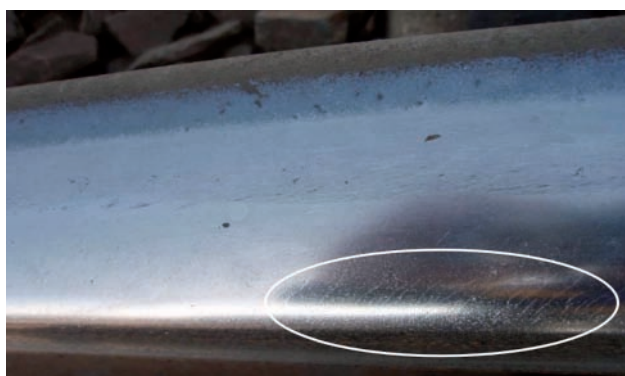
Fig. 1. Rail head checks at their initial stage [photo by I. Mikłaszewicz]

During use, the rail running surface undergoes significant changes, such as deformations and the formation of surface defects. The main defects posing difficulties are all types of edge cracks, i.e. *head checks* (2223) [2] (Figs. 1, 2) and surface cracks, i.e. *squats* (227) [2] (Fig. 3) [3]. There are also other defects such as *shelling* (222) [2], corrugations, burns, transverse and horizontal cracks or excessive wear [4]. These defects contribute to passenger discomfort while simultaneously posing safety risks. Dealing with these defects is very challenging and requires significant financial investment. During operation, the track is

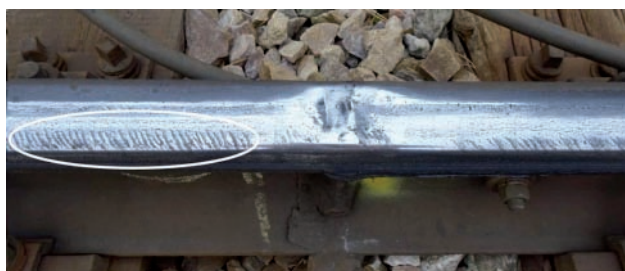
Fig. 2. Head checks of varying severity in the immediate vicinity of the welded joint [photo by I. Mikłaszewicz]

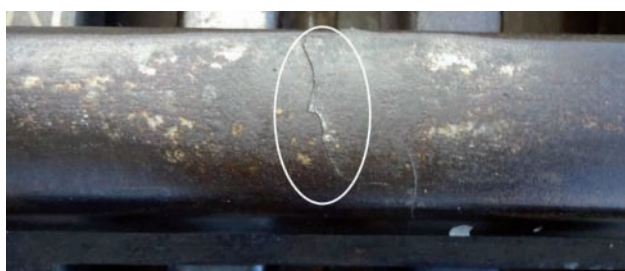
Fig. 3. Rail squat defect [photo by I. Mikłaszewicz]

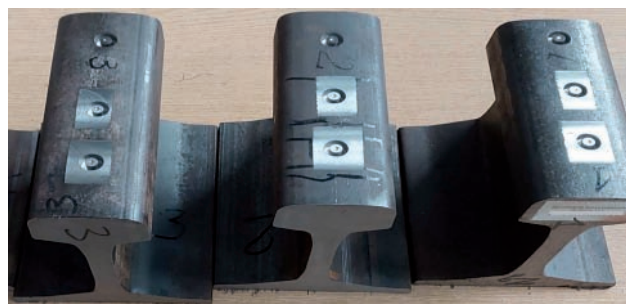
Fig. 4. Sections of the three rail grades used in the tests [photo by I. Mikłaszewicz]

The rail samples were subjected to surface milling to depths of 0.3 mm and 0.5 mm to remove the decarburised surface layer (Fig. 4). The prepared rail surface was then drilled with a core drill of 15 mm diameter to a depth of 8 to 9 mm (Fig. 5). During the sample preparation process, an 8-mm-diameter cylinder was centrally pressed into a cone with a 60-degree opening angle at a force build-up rate of 40 kN/min, recording the indentation force F expressed in kilonewtons and the penetration depth of the cone tip h into the rail material, expressed in millimeters. The test was halted at the moment of material fracture.

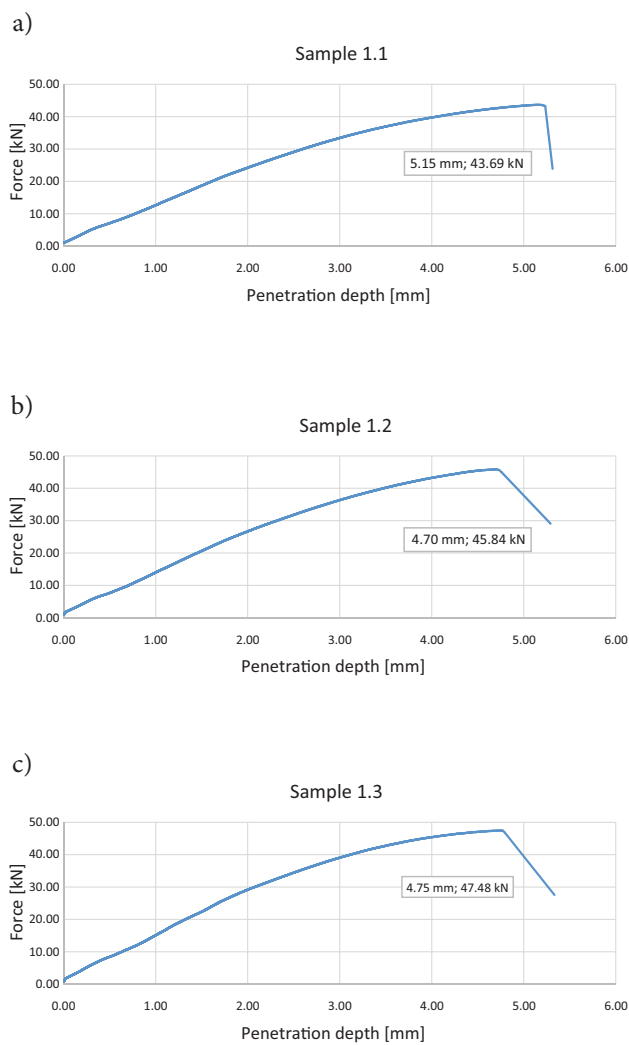
Fig. 6. Relationship between the force and cone indentation depth in R260 rail: a) without milling, b) in a surface milled to a depth of 0.3 mm, c) in a surface milled to a depth of 0.5 mm [prepared by J. Michalik, I. Mikłaszewicz]

The results for the cracking force F , penetration depth h , cone area S_b and calculated W_p are shown in Table 4. The graphs (Figs. 6–8) illustrate the relationship between the force F and the cone penetration depth h for non-milled and milled rails (Figs. 6–8).

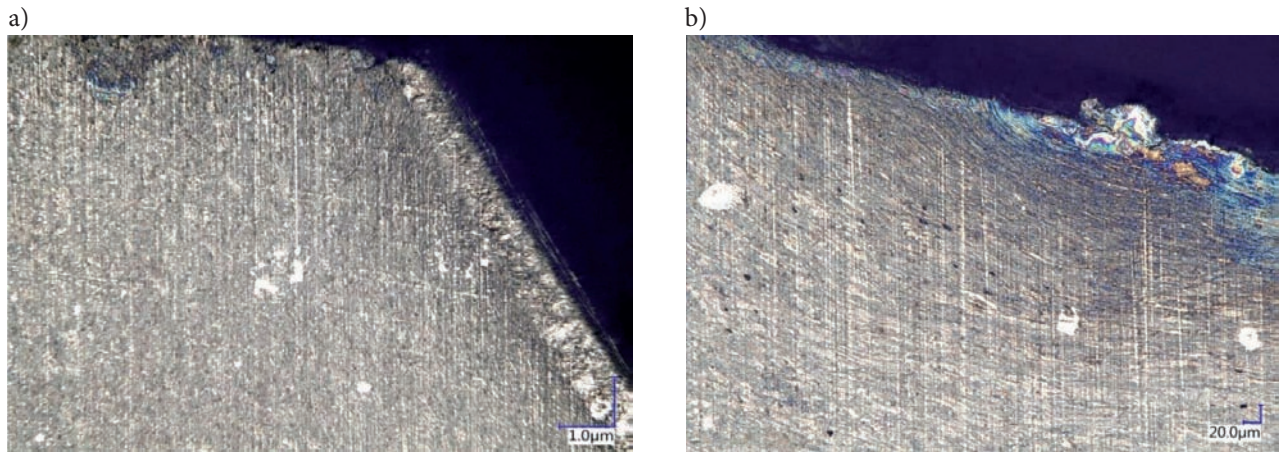
Fig. 10. Cracking of the R350HT rail running surface after testing: a) beginning, b) middle [photo by I. Mikłaszewicz]

Figure 9 shows the microstructure at the beginning, middle, and bottom of the cracked surface layer of R260 rails after cone indentation. A strong crushing of the material is visible near the rail surface, in the middle section, and at the bottom. Meanwhile, Figure 10 shows the structure at the beginning and middle of the surface layer after cone indentation in the R350HT rail.

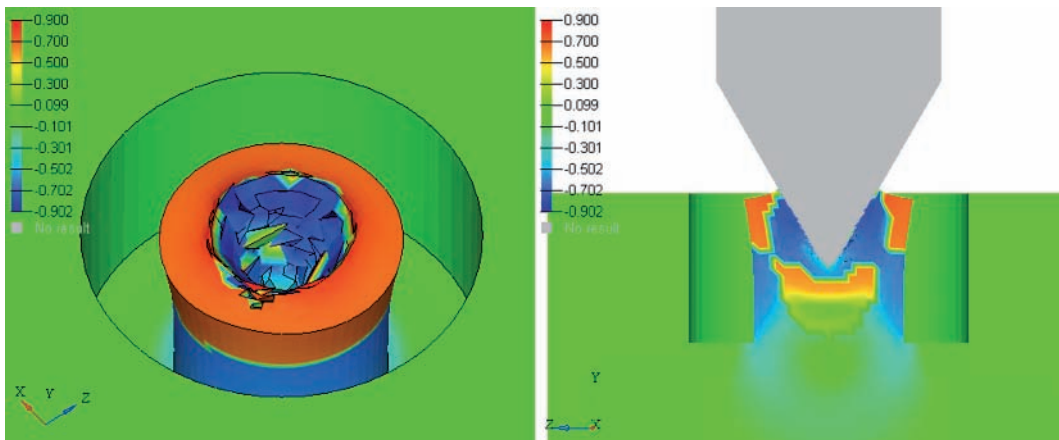
Fig. 13. Reduced von Mises stresses including tension and compression [prepared by R. Bińkowski]

The stresses occurring on the R260 rail running surface during cone indentation, as determined by a finite element analysis (FEA) simulation, reach a level of +900 MPa when calculated as von Mises equivalent stress considering tension (Figs 11–14). When considering both tension and compression, the stresses are also approximately ± 900 MPa, which is within the limits required by the EN 13674-1+A1:2017-07 standard for the tensile strength of R260 steel (880 MPa).
