# Identifying Rail Running Surface Defects by Means of Vibroacoustic Signals

## Summary

The article presents the concept of a method to identify the most common defects occurring on the rail running surface using vibroacoustic signals. The article provides a description of rail defects, such as: squat, running surface defect and wheelburns. It covers the methodology adopted in the conducted research and the results of analyses of recorded signals for the technical–operating conditions occurring on railway lines no. 213 Reda – Hel and no. 131 Chorzów Batory – Tczew. The presented results of vibration and noise measurements concern recorded signals for defective track sections and for control track sections. The conducted synthesis of research findings proves the legitimacy of developing a method involving the use of vibration signals for the purpose of diagnosing the rail running surface, and indicates an opportunity to take advantage of vibroacoustic signals to evaluate the condition of other elements of track superstructure.

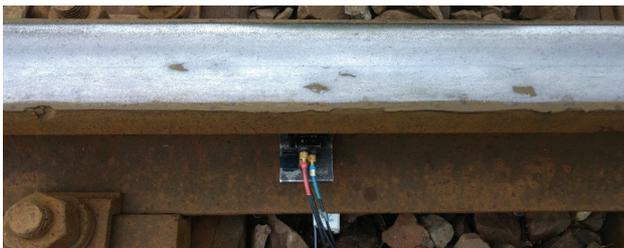
Fig. 2. Defect 221 – running surface damage [authors' own work]

The last of the analysed defects is the rail running surface defect no. 221, according to PLK's Catalogue of Rail Defects (Fig. 2). Defect no. 221 is a defect of metallurgical origin. It appears on the rail web during the standard use and operation of the track. Its most common manifestations include shelling of the running surface or groove-shaped cracks.
